## AIRCRAFT ACCIDENT REPORT

IN-FLIGHT FIRE/EMERGENCY LANDING  
FEDERAL EXPRESS FLIGHT 1406  
DOUGLAS DC-10-10, N68055  
NEWBURGH, NEW YORK  
SEPTEMBER 5, 1996

The National Transportation Safety Board determines that the probable cause of this accident was an in-flight cargo fire of undetermined origin.

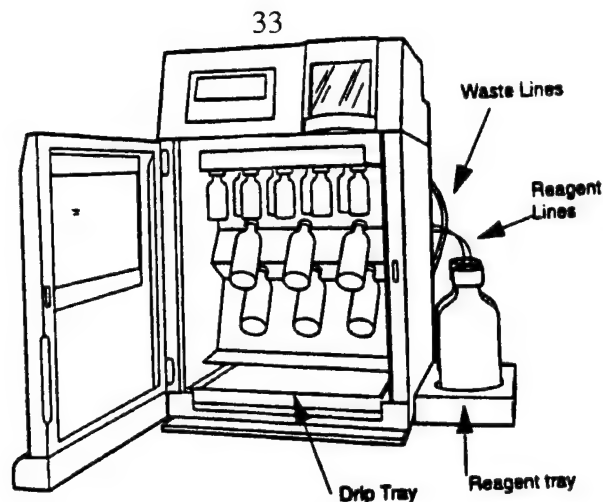
Figure 8.—Expedite Model 8909 DNA synthesizer instrument cabinet.

The Expedite Model 8909 DNA synthesizer was found in the center of container 6R lying on its left side with the top facing forward (as viewed from aft looking forward), the front towards the right side of the airplane, and the bottom facing aft (see figure 8 for a diagram of the synthesizer). The unit contained several bottles with labels that included flammability symbols, and some of the bottles contained liquid. One large bottle in the aft row had a very strong odor when it was removed from the unit. Because this unit was found at the lowest point of the "V" burn pattern, the Safety Board investigation evaluated and analyzed the liquids contained in this unit.
